**NORWAY/UNITED STATES DESIGN PROTECTIVE
AIRCRAFT SHELTER (PAS) QUANTITY-DISTANCE
PROGRAM 1/3-SCALE TEST SERIES**

**Volume I of V
PAS 1-4 Summary**

Final Report

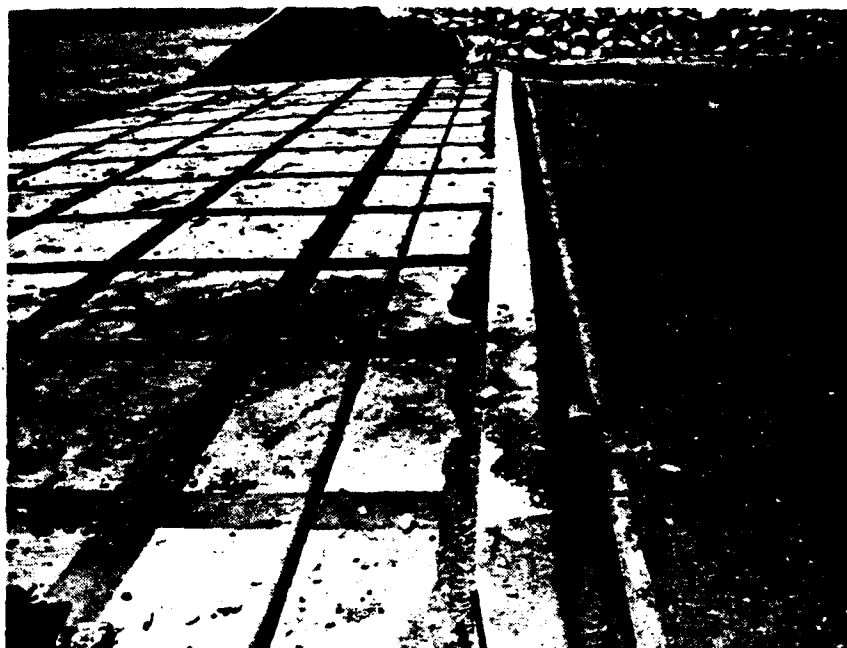
The top plate of the door trench was found slightly deformed along its length, and the concrete adjacent to the outside edge of the top plate had spalled away (Fig. 221). The heaviest spalling was located near the door hinge pins.

Figure 221. Top plate of door trench and front foundation, PAS-4.

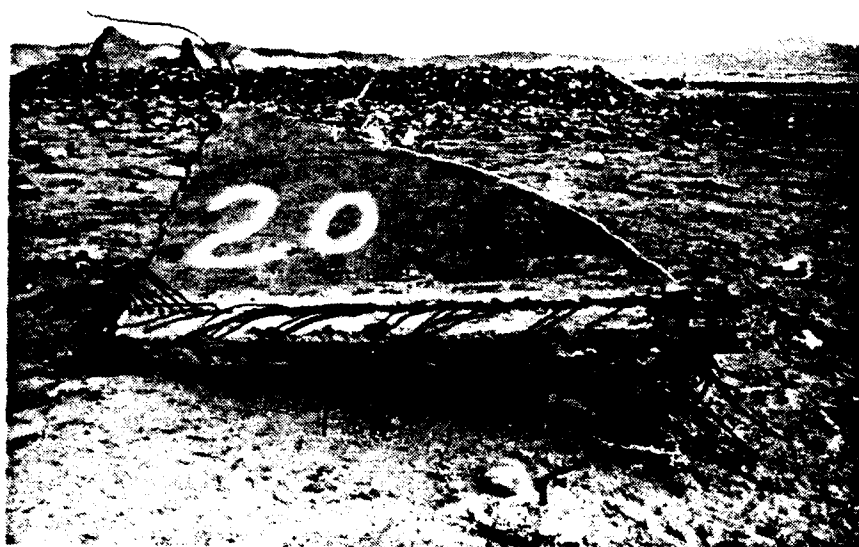
Figure 222. Final location of right front wall, PAS-4.

The right front wall was found intact 25 m from the right side of the shelter (Fig. 222). The left front wall, including the heavily reinforced column next to the personnel entrance opening, was found attached to the adjacent section of the arch. All of the reinforcing dowel bars were pulled out of the base of the column and remained in the front foundation. Both of the front walls were pulled out of the steel plate liner, breaking every headed anchor stud in the process. Most of the dowels between the wingwalls and the front walls remained in the front walls.

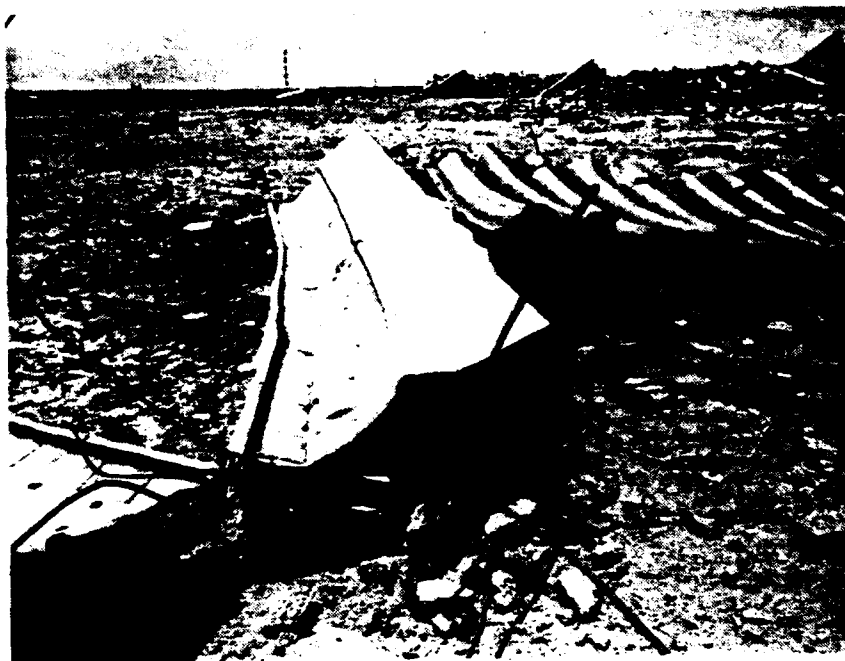
The headworks liner was torn in half along a welded joint near the crown of the arch. The two pieces remained attached to the adjacent large sections of the arch. The top parts of the liner were bent outward (Fig. 223). The concrete in the parapet was rubbleized, exposing the large threaded bars, most of which remained attached to the pair of channels welded to the liner plate (Fig. 224).

Figure 223. Deformed steel plate headworks liner, PAS-4.

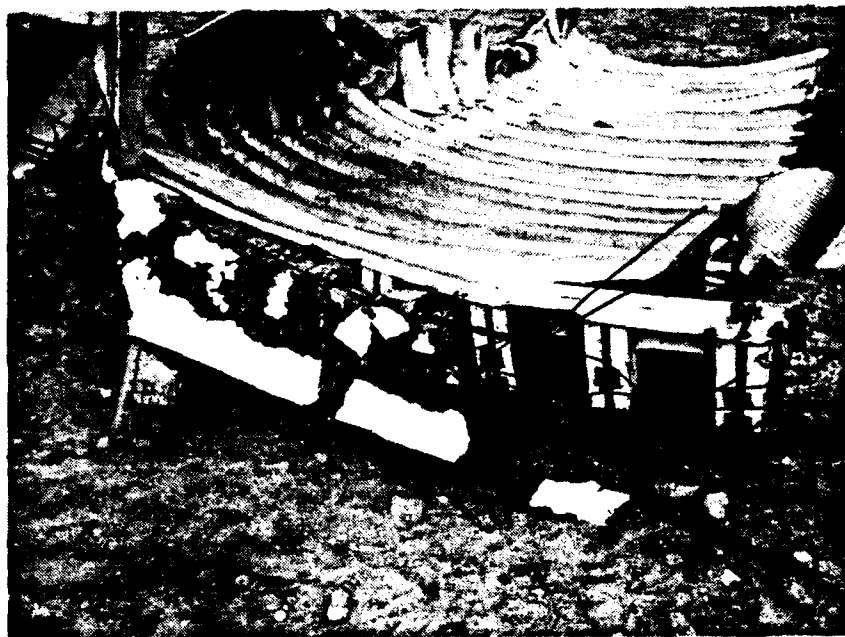
Figure 224. Rubbleized concrete in parapet, PAS-4.

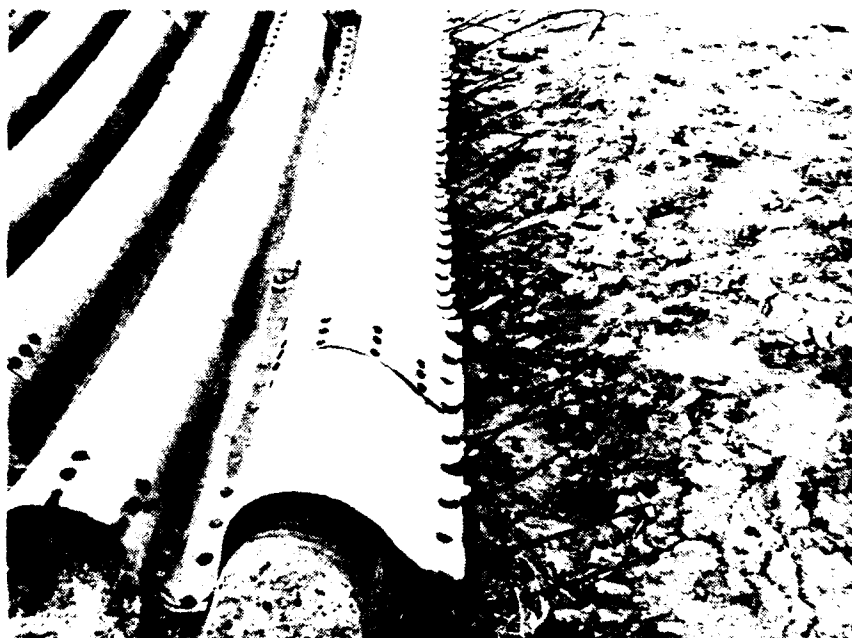
Arch failure in the transverse direction always occurred along a bolted liner joint. At the failure line, the concrete failed in tension, and the corrugated liner material was almost always pulled over the nut and washer of the bolt (Fig. 227). Figure 228 shows the location of the transverse failure planes in relation to the location of the splices in the two layers of longitudinal reinforcing bars. Where the failure plane was at, or near, a line of splices in the reinforcing bars, the bars pulled out of the adjacent piece (Fig. 229). At the other failure planes the reinforcing bars were found to have failed in tension at the fractured face of the concrete (Fig. 230).

Figure 227. Typical bolt pull-out at liner joint, PAS-4.

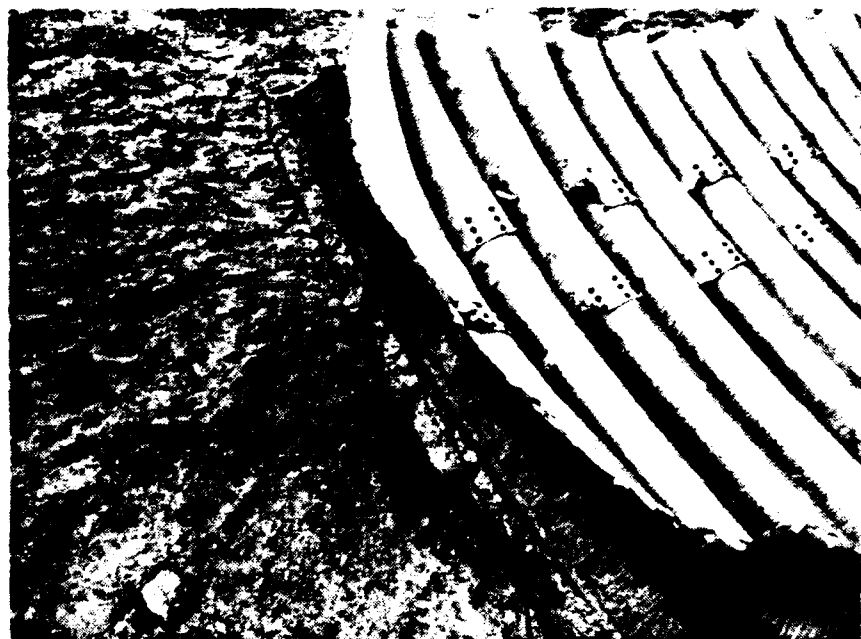
Figure 229. Pull-out of reinforcing bars at transverse failure plane, PAS-4.

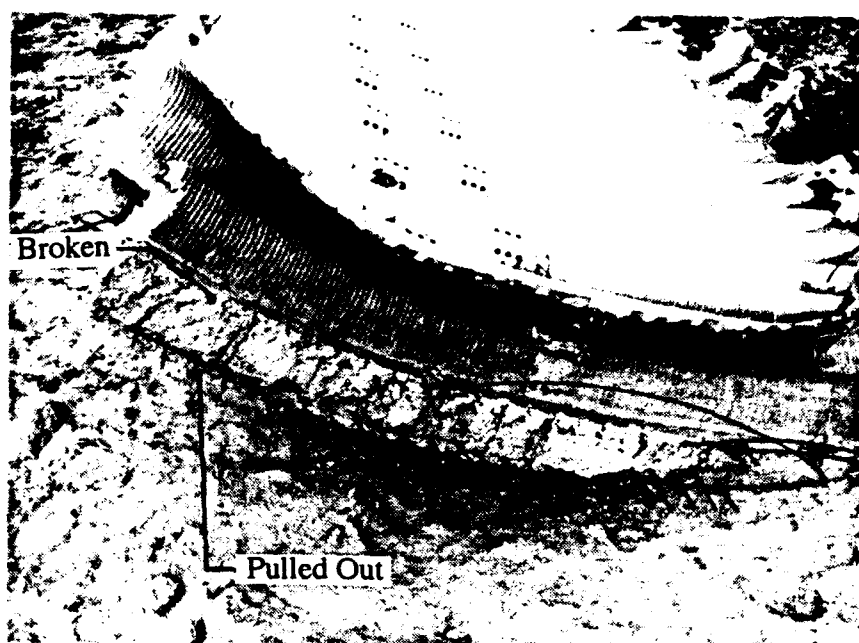
Figure 230. Broken reinforcing bars in transverse failure plane, PAS-4.

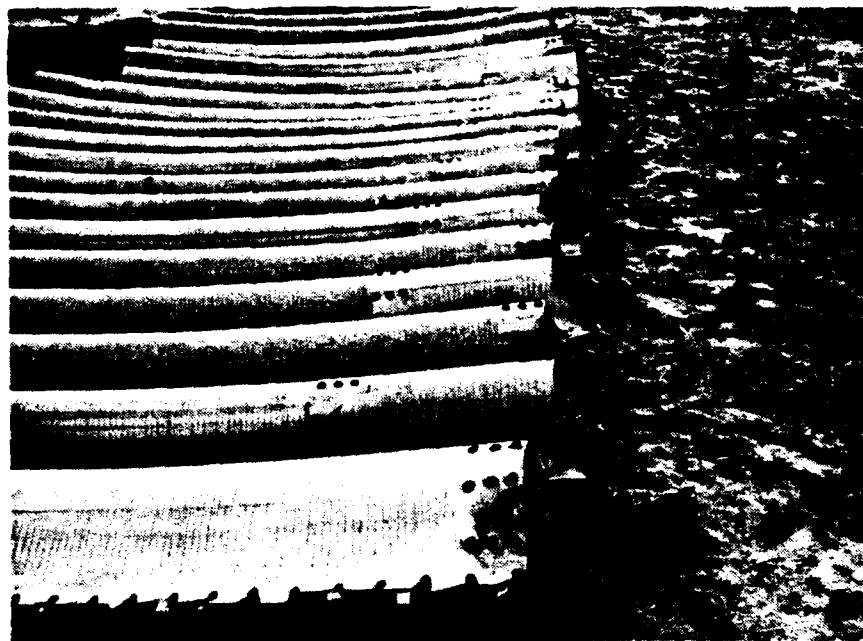
Five longitudinal failure planes in the arch were identified (Fig. 231). One of the longitudinal failure planes was along the crown of the arch. Two occurred at or near the splices in the transverse reinforcing bars. The remaining two were found at or near the location where the upper arch section begins to thicken near the foundation. At each of the failure lines, the corrugated liner material was ripped apart in tension (Fig. 232). Although the upper three failure lines occurred near the bolted joints between liner segments, the presence of the joints did not appear to influence the formation of the failure planes or the tearing of the liner. The liner was observed to have torn exactly at a bolted joint in only a few isolated locations. At the longitudinal failure plane, the concrete failed in tension. Along the failure plane at the crown and at

Figure 232. Liner failure at longitudinal failure plane, PAS-4.

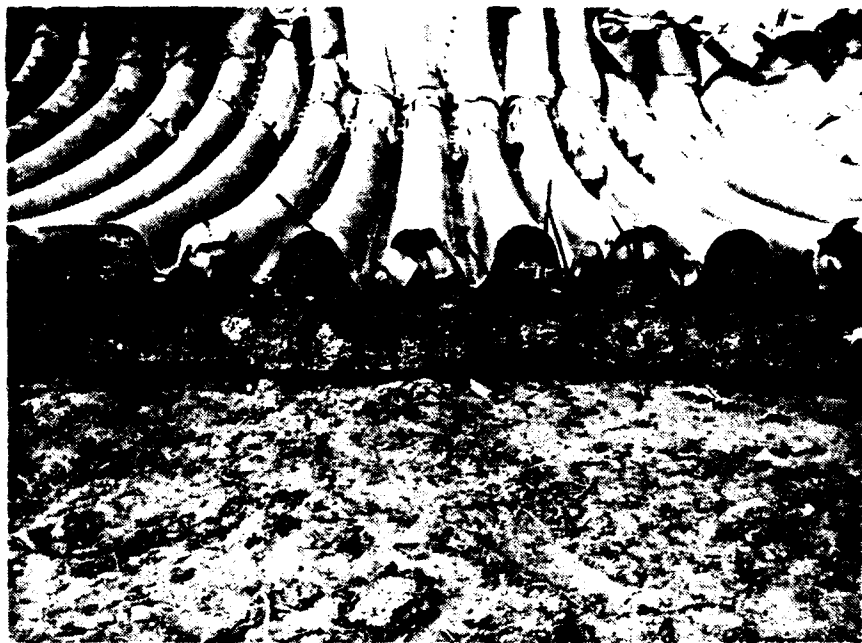
the two failure planes near the foundation, the transverse reinforcing bars failed in tension at, or within a few millimeters either side of, the fractured face of the concrete. At the two failure planes near the splices in the transverse reinforcing bars, most of the bars were found to have pulled out of the lower arch sections (Fig. 233); however, a few longitudinal failure planes at this location had a combination of both failed and pulled-out bars.

Figure 233. Pull-out of reinforcing bars at transverse failure plane, PAS-4.

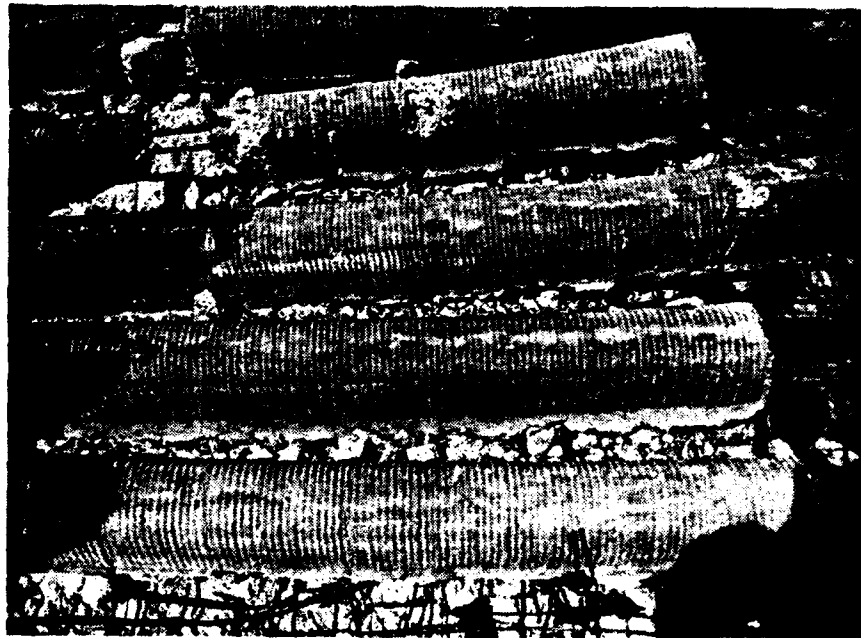
An examination of the fractured face of the longitudinal failure plane revealed tension cracks ranging from hairline to several millimeters in width at almost every transverse liner joint (Fig. 234). There were fewer of them in the thickened arch sections near the foundation. The tension cracks in these sections were also narrower in width and randomly spaced along the edge as compared to those associated with the liner joints. Transverse cracks were also seen on the surface of the arch sections (Fig. 235).

Figure 234. Tension cracks at transverse failure plane, PAS-4.

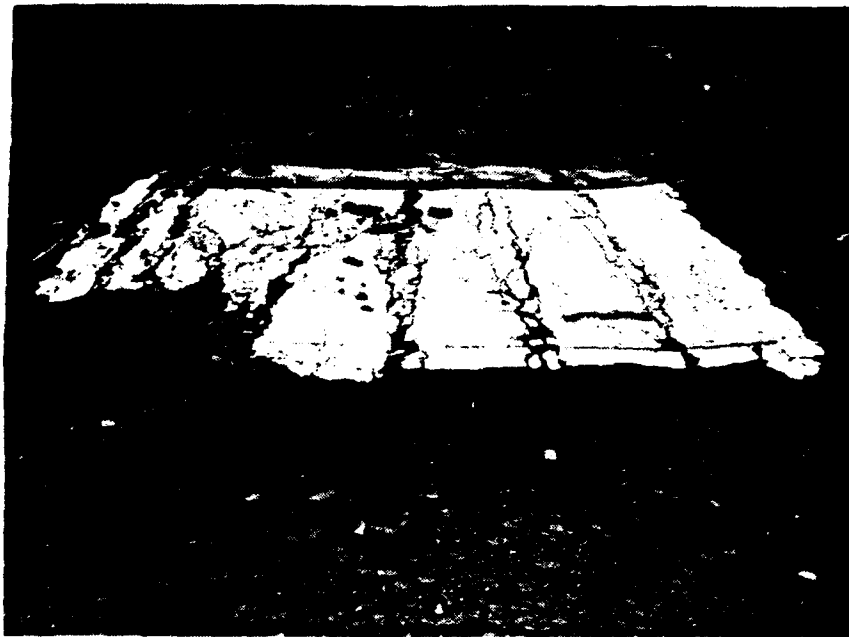
Figure 235. Typical transverse cracks on surface of arch sections, PAS-4.

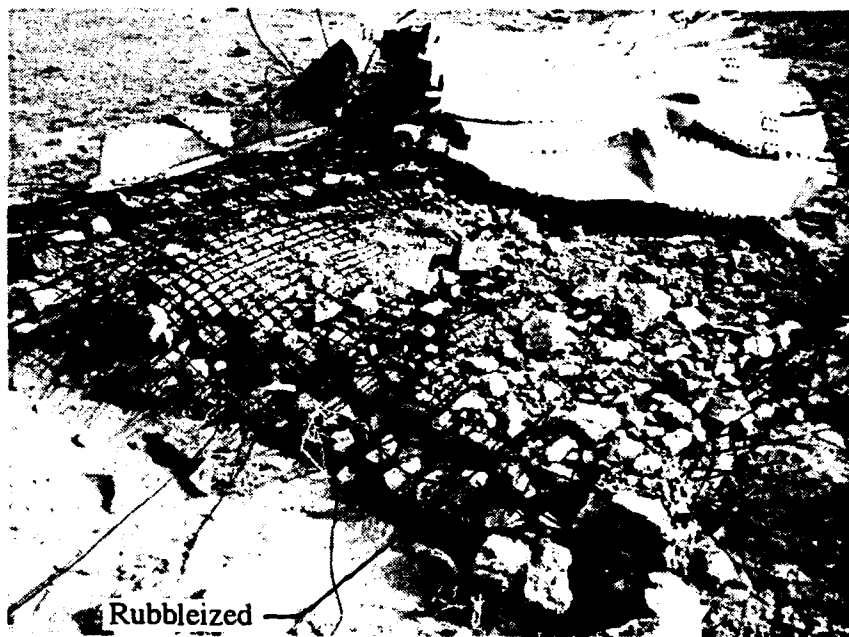
The high-speed photography shows that most of the large arch sections generally maintained their initial breakup geometry during the flight. The arch sections impacted the ground in a variety of positions. Some of the sections maintained their curved arch geometry after impact, and others were flattened or folded. In some cases the corrugated liner was still attached to the concrete. In several cases the sections broke up and produced various amounts of secondary debris. Two sections were almost totally rubbleized with very little secondary debris surrounding them (Fig. 236).

Figure 236. Rubbleized arch section, PAS-4.

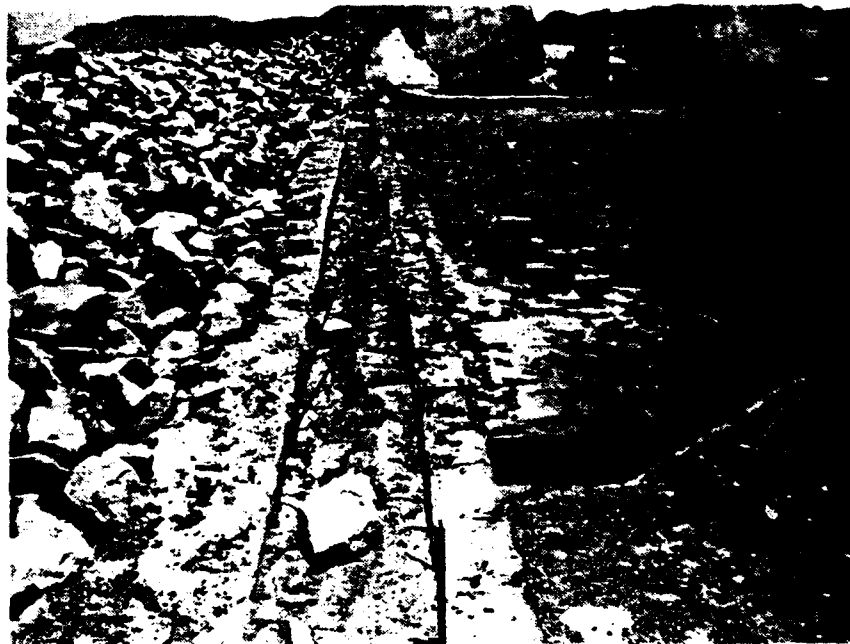
Figure 237. Top of arch foundation, PAS-4.

The arch foundation was found generally free of debris or rock rubble (Fig. 237). There was little indication of upward or outward displacement of the arch foundation. All of the outside dowel bars had either been broken at the top of the foundation or broken off inside the foundation and pulled out (Fig. 238). About one-fifth of the inner dowel bars were broken at the top of the foundation. The rest appeared to have been pulled out of the base of the arch and remained in the arch foundation. No transverse cracks were noted in the arch foundation.

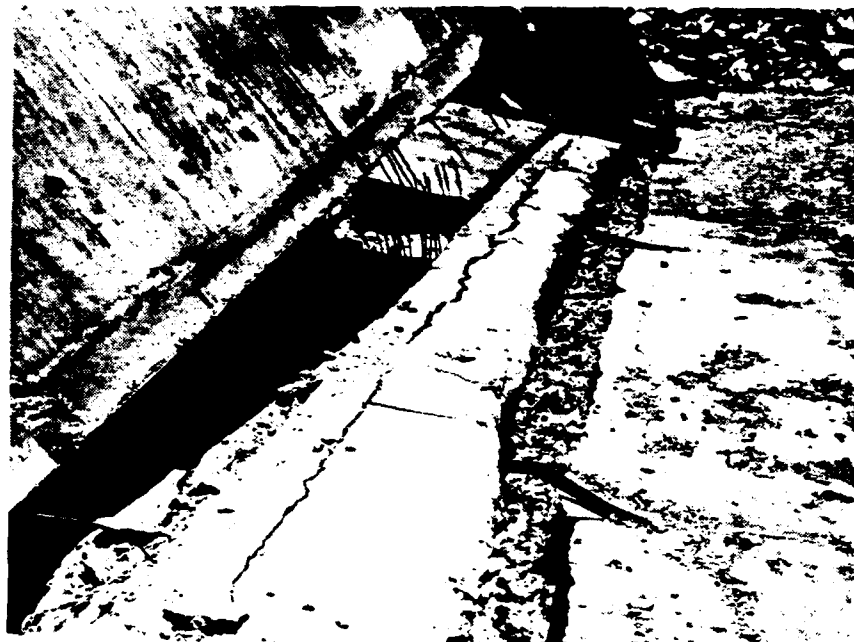
A 220-mm-wide gap was noted along the full width of the floor slab in front of the backwall (Fig. 242). The break occurred about 330 mm from the face of the backwall. Bars of the reinforcing mesh in the floor slab were broken on either side of the gap. There was also a 20-mm-wide crack running parallel to the large gap about 110 mm from the inside face of the backwall. The large gap appeared to correspond to the ends of the reinforcing bars running from the backwall foundation into the floor slab. The smaller crack corresponded to the inside edge of the foundation (Fig. 243).

Figure 242. Gap between floor slab and backwall, PAS-4.

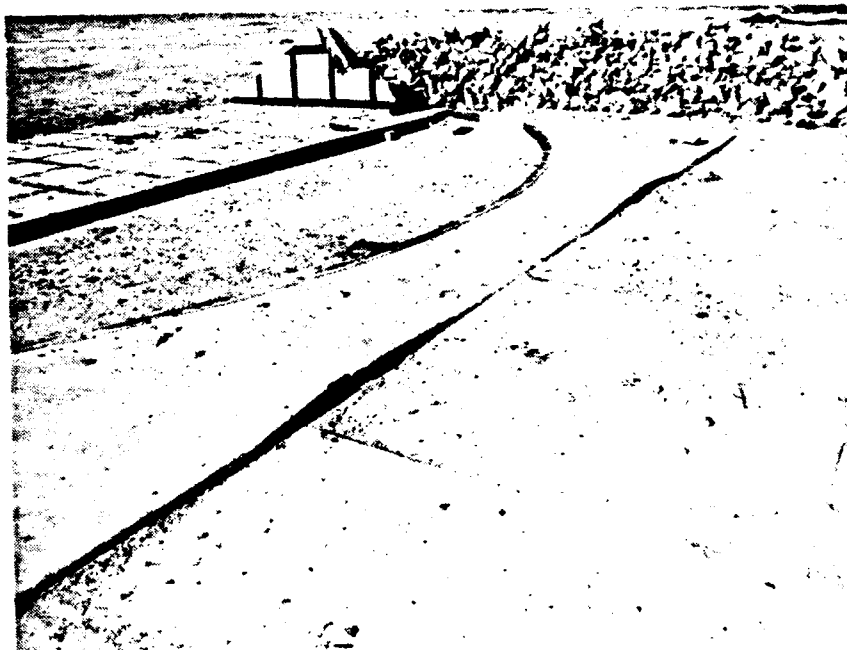
At the expansion joint between the floor slab and the heavily reinforced door pit area, the expansion material had been pushed up out of the joint (Fig. 244). The floor slab had been pushed downward relative to the door pit slab by about 15 mm. There was no horizontal displacement between these two components.

Figure 244. Posttest condition of expansion joint, PAS-4.

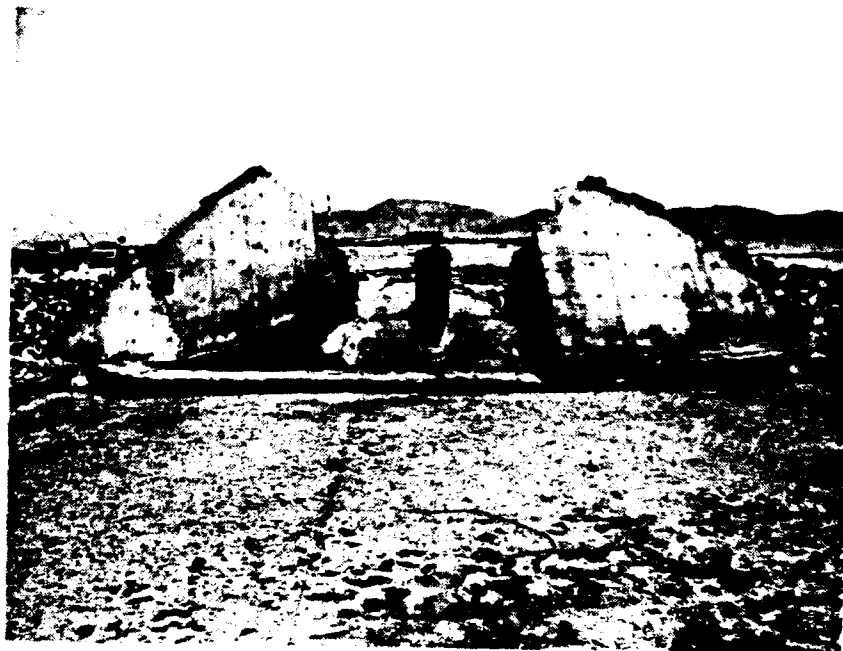
The center section of the backwall over the exhaust port opening had broken away along diagonal lines running from the upper corners of the exhaust port opening (Fig. 245). This section was found in two pieces about 9.1 m behind the shelter. The two remaining sections of the backwall on either side of the opening had broken away from the foundation and were pushed backwards about 200 mm. These walls had tipped backward approximately 30 deg (Fig. 246).

Figure 245. Posttest view of backwall, PAS-4.

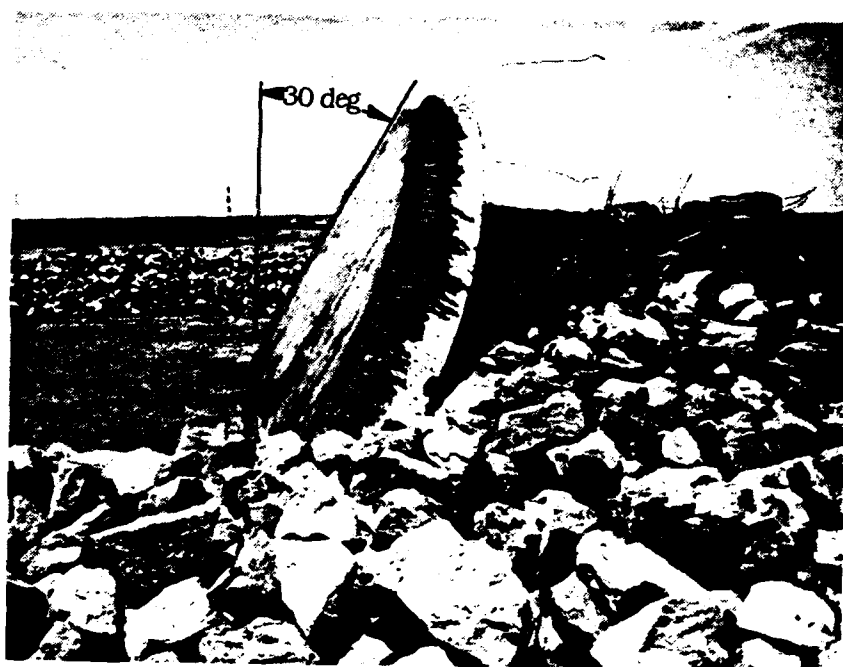
Figure 246. Thirty-degree backward rotation of backwall, PAS-4.

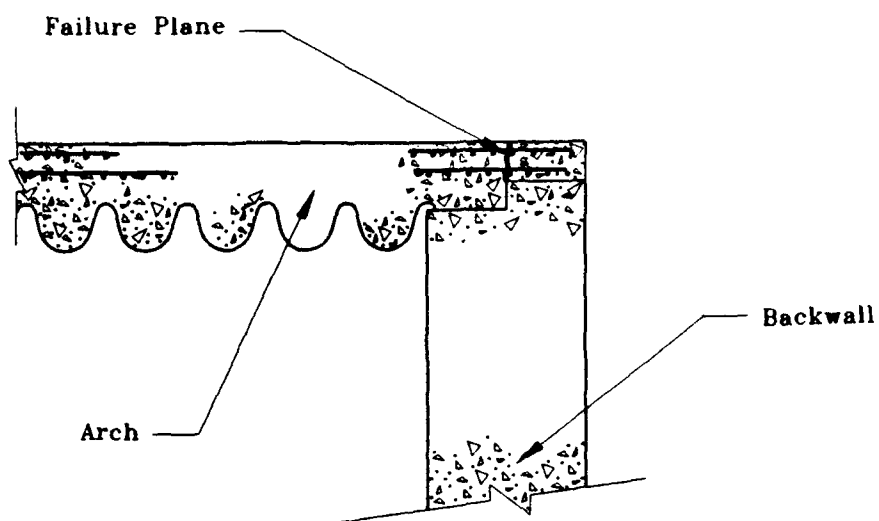
The arch had separated from the top edge of the backwall at the inside horizontal interface. The failure plane then proceeded along a vertical plane corresponding to the step in the joint (Fig. 247). Most of the arch concrete beyond the vertical step remained on the backwall. About half of the reinforcing bars crossing the failure planes had failed in tension; the rest of the bars pulled out of the arch concrete and remained in the top of the backwall (Fig. 248).

Figure 247. Section: Failure plane between arch and backwall, PAS-4.

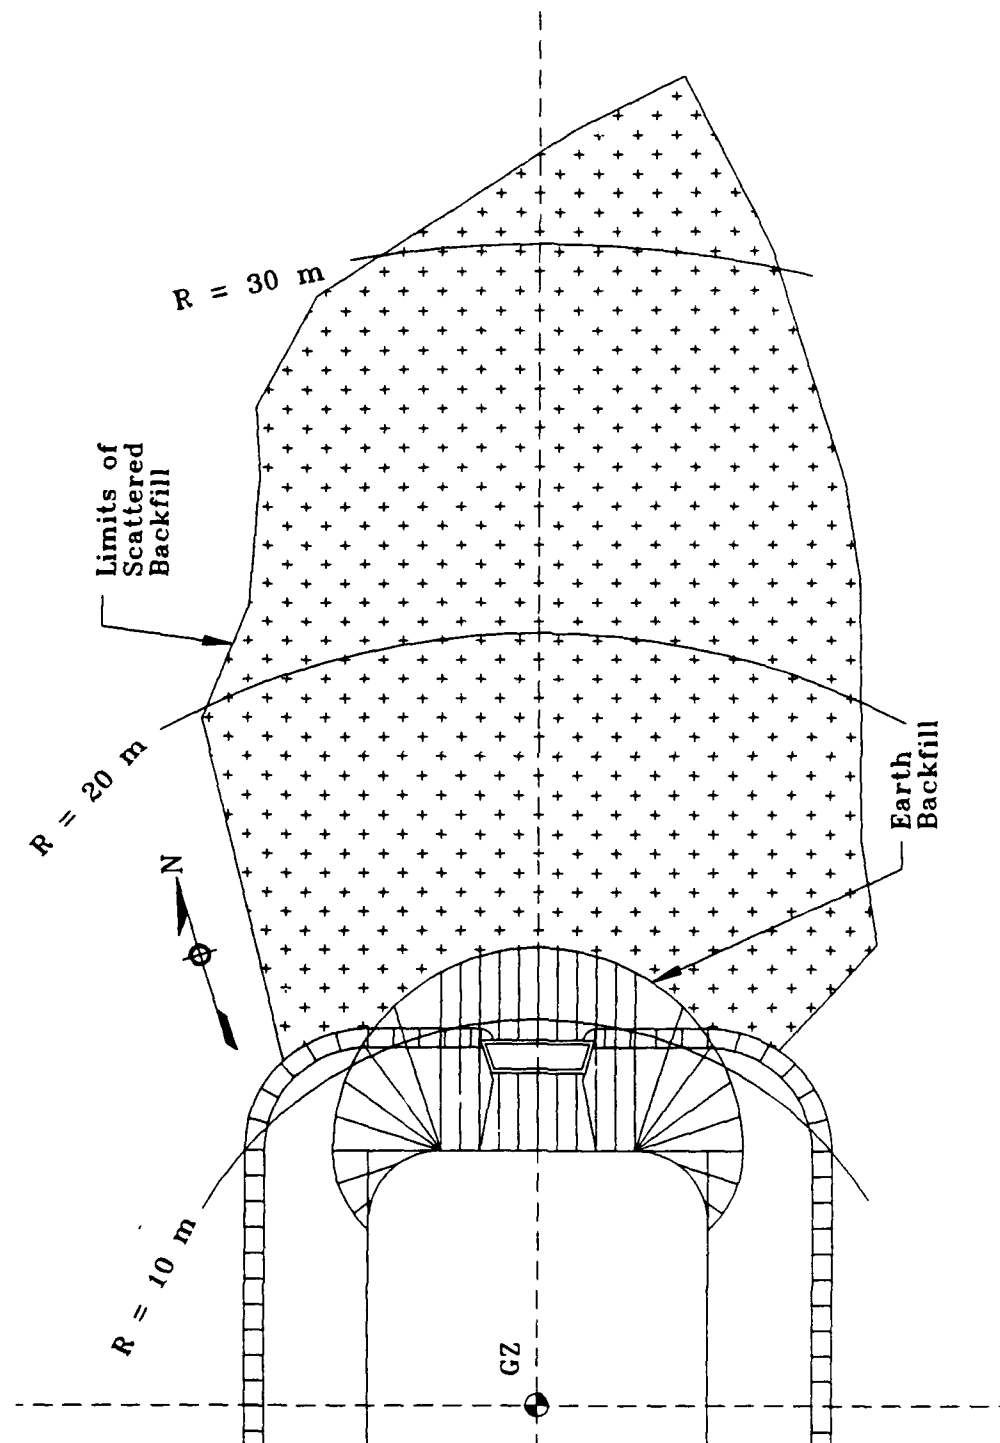
The earth backfill originally against the outside of the backwall had been thrown back behind the shelter. Figure 249 shows the limits of the displaced earth backfill.

Figure 249. Limits of ejected earth backfill, PAS-4.

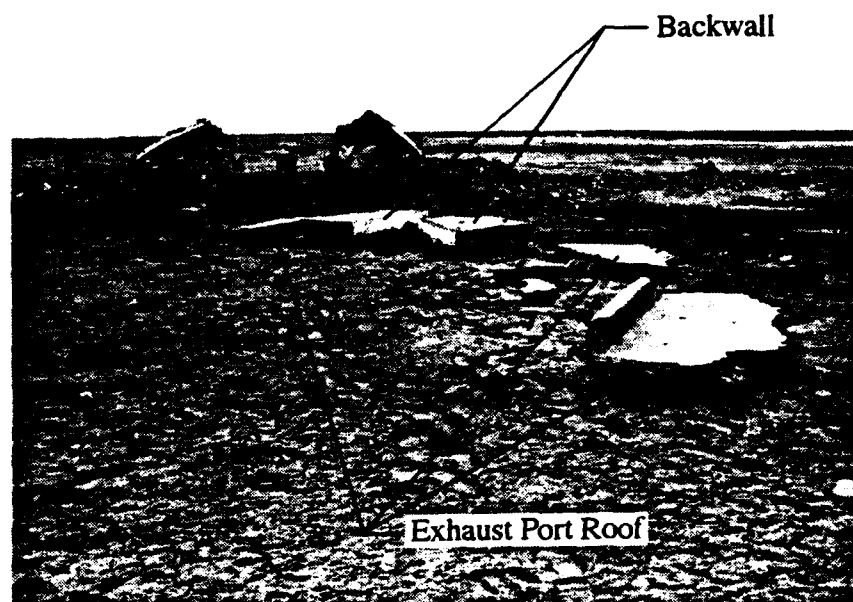
The exhaust port was displaced backward and severely damaged during the test. The roof and a portion of the backwall, had broken away from the top of the walls and was found in three pieces approximately 24.7 m behind the shelter (Fig. 252). Figure 253 shows the breakup pattern of the roof. The dowels connecting the roof and the walls all failed in tension. Both of the sidewalls had broken away from the floor slab and the backwall and tipped upward at the backwall. Both sidewalls also had large open areas

Figure 252. Exhaust port roof and center section of backwall, PAS-4.

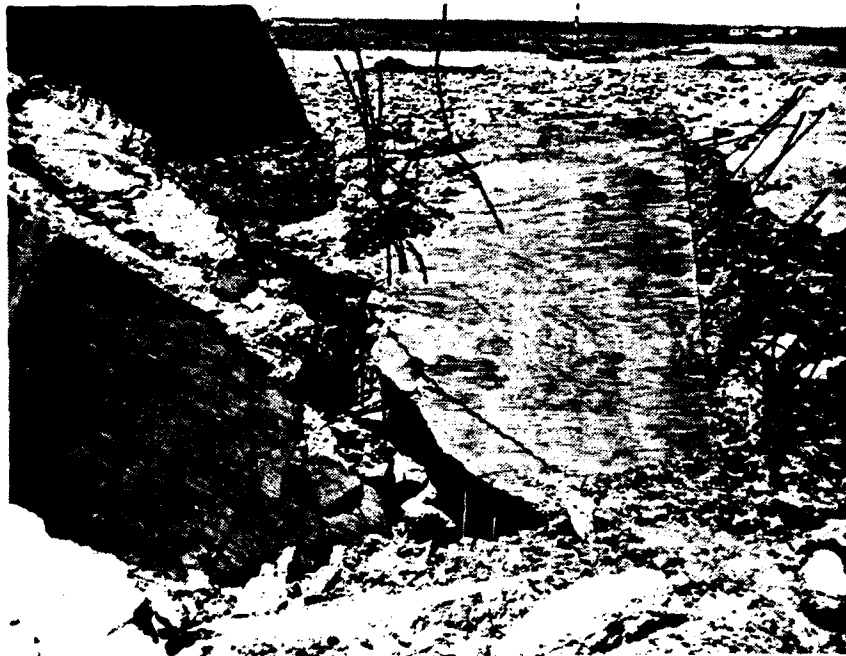
Figure 255. Right sidewall of exhaust port, PAS-4.

of rubbleized concrete at the location where the wall thickness changed (Figs. 254 and 255). The reinforcing bars in these rubbleized areas were broken and severely deformed. Although the center wall was also broken from the floor slab, it remained relatively undamaged (Fig. 256).

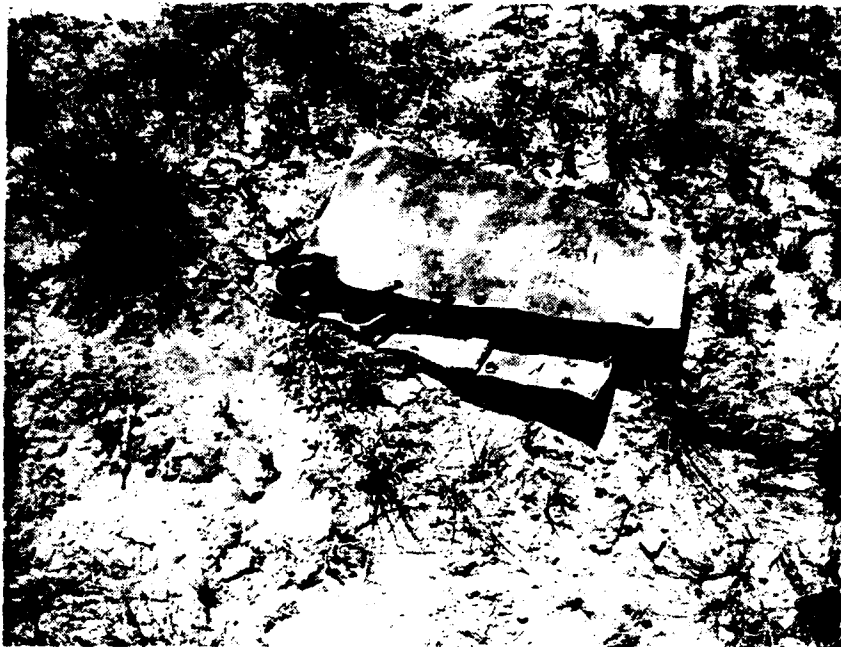
The two steel doors in the exhaust port were found folded tightly in half about a horizontal line (Figs. 257 and 258). The doors had been blown upward and out the back of the exhaust port and were found at 121.2 and 116.2 m behind the structure. Abrasions on the doors may indicate that the doors struck the exhaust port endwall as they were blown out.

Figure 257. Steel door from left side of exhaust port, PAS-4.

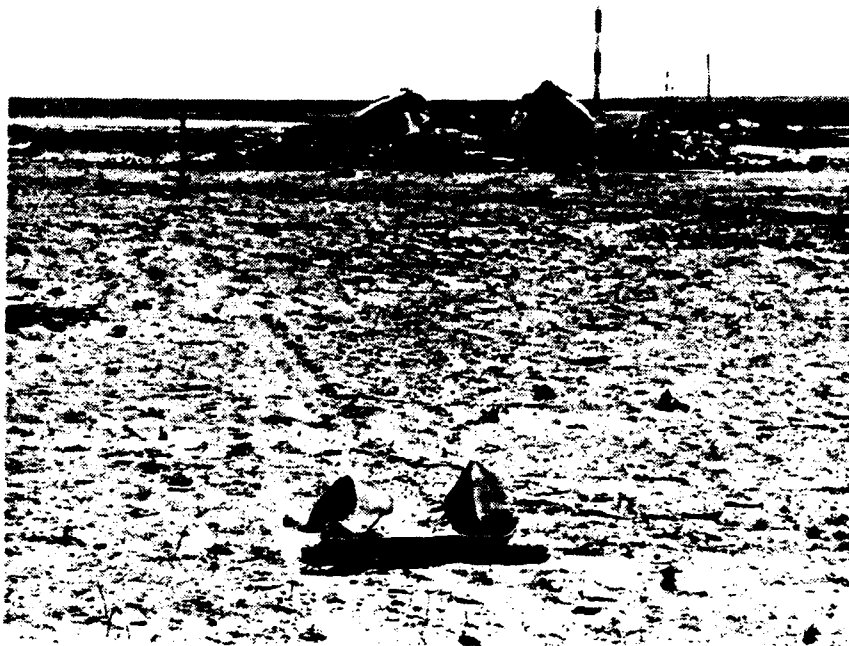
The two steel door frames originally embedded in the floor, walls, and roof of the exhaust port were also found in several pieces behind the structure (Fig. 259). The headed anchor studs were broken near the welds attaching them to the frames and remained embedded in the concrete walls, roof, and floor. In all cases the steel angles at the top and bottom of the doors were found still welded to the frame.

Figure 259. Steel frame for exhaust port door, PAS-4.

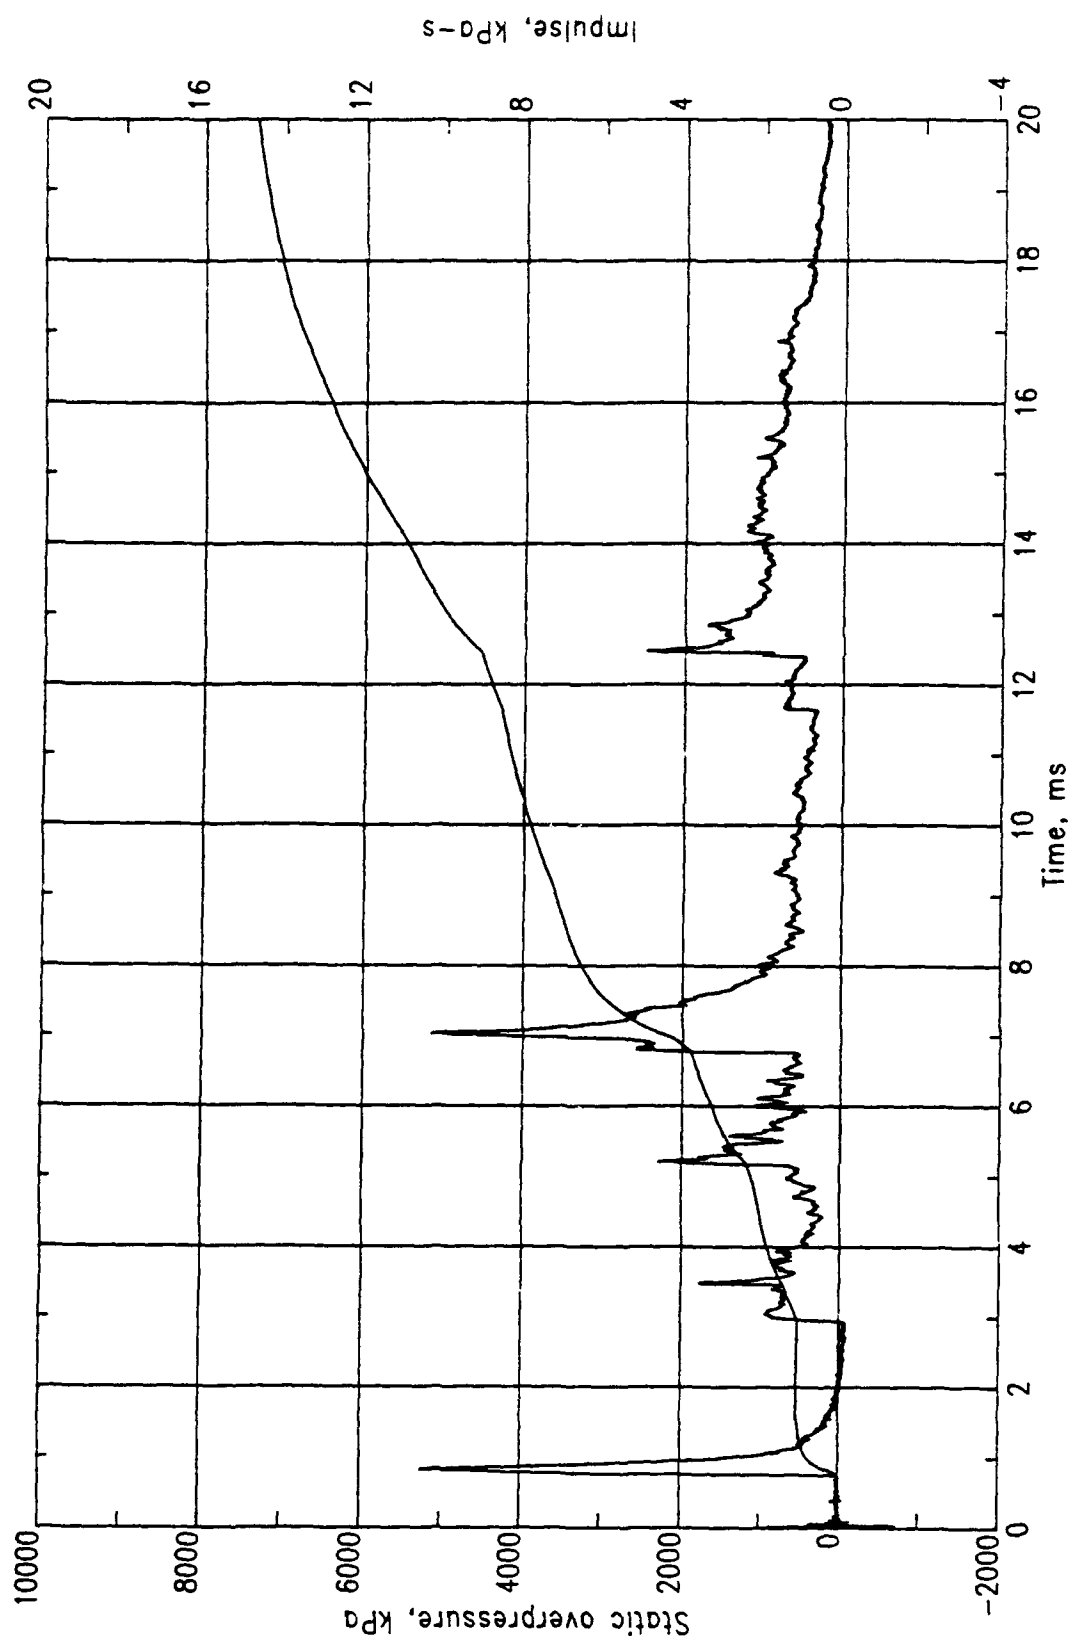
Figure 262. PAS-4, MN 0601.

Measurement Number 601 was made in the floor 1.85 m from GZ towards the side of the shelter. It shows a peak pressure of 8.59 MPa (Fig. 262). The INBLAST code predicted 1.16 MPa at this location. Measurement Number 301, made in the floor 2.84 m from GZ towards the front door, shows a peak of 5.18 MPa (Fig. 263).

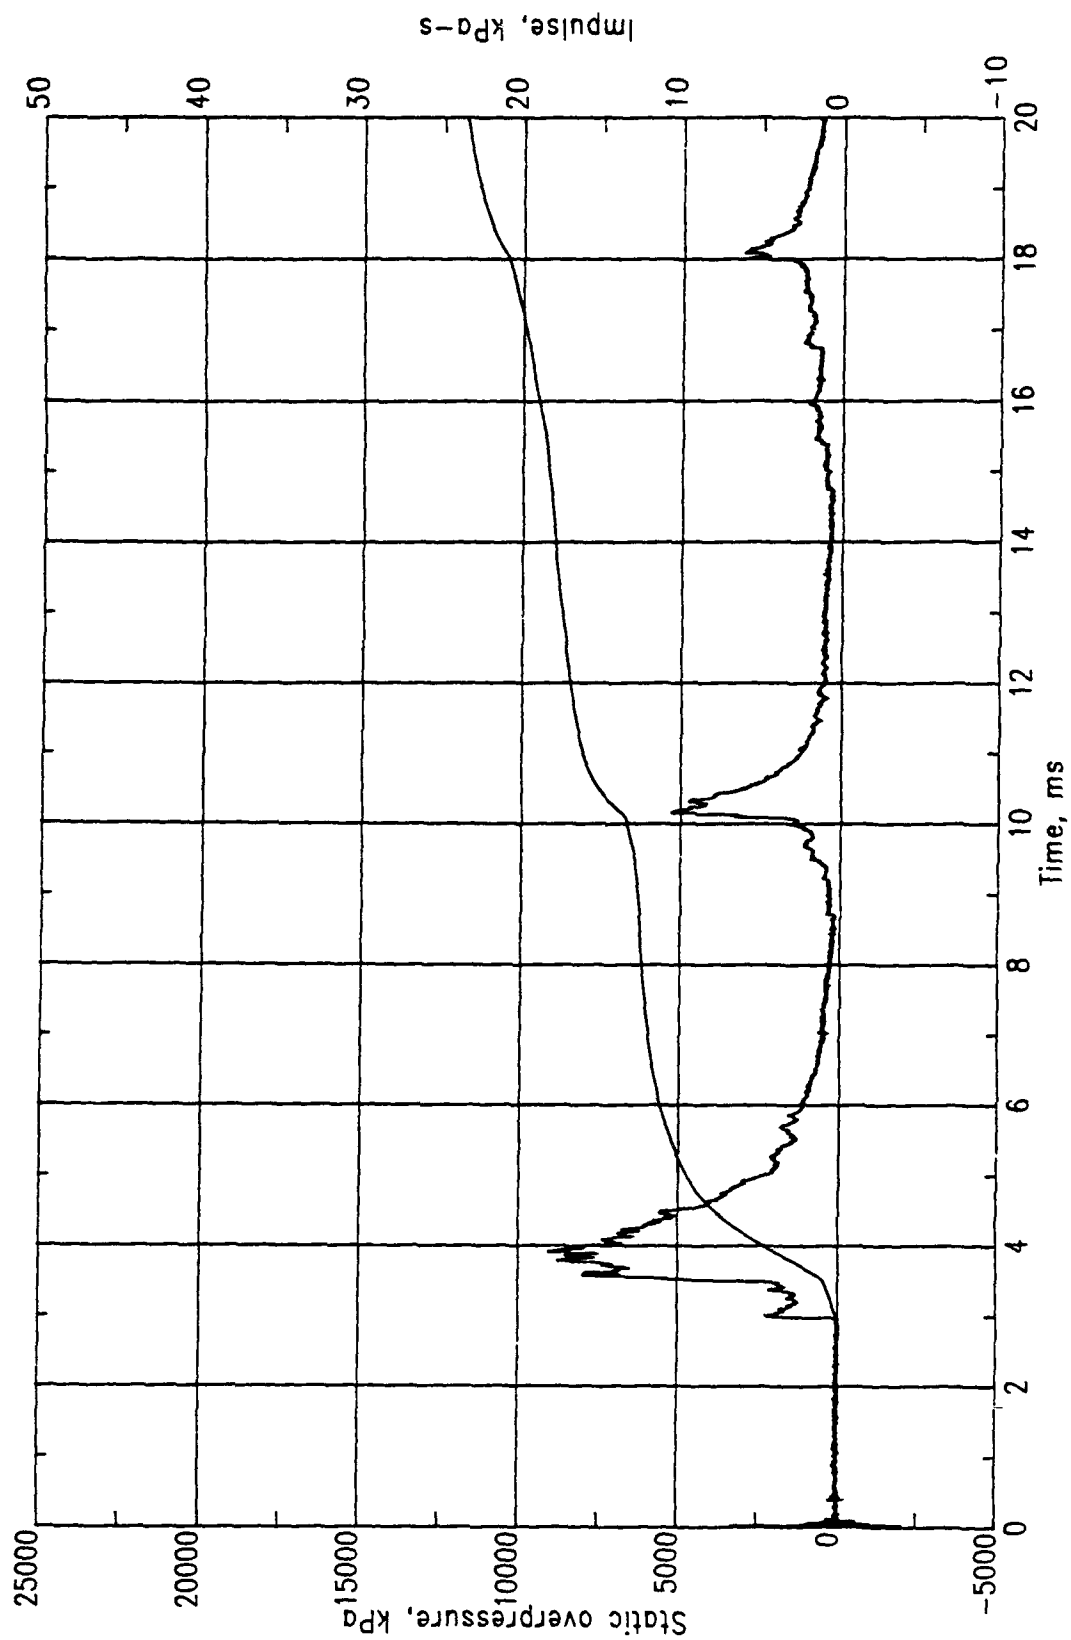
Figure 267. PAS-4, MN 0102.

Measurement Number 102, at about the same location near the left rear corner of the shelter, recorded a peak of 8.95 MPa (Fig. 267).
